Manhole Inspection Summary

Manhole # S37Q__015MH

Location Address: **e.cross st**

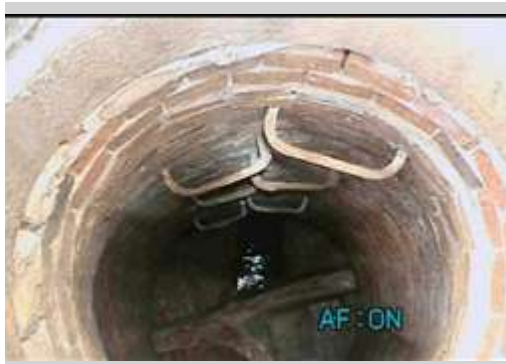
Defect 3

Count: **6** Missing: **0** ☒ **Corroded**

steps

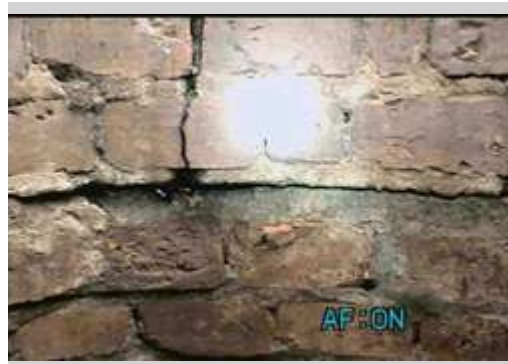
Defect 2

Condition: ☐ Sound ☒ **Cracked** ☐ Root Intrusion ☐ Loose Brick ☐ Deteriorated

corbel cracked

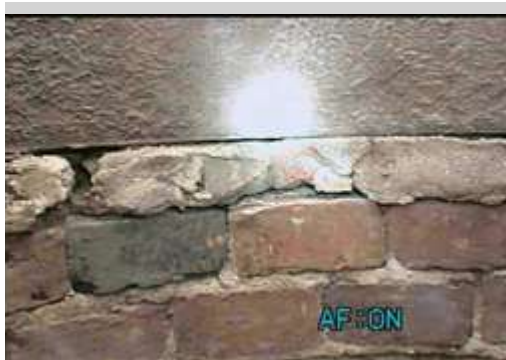
Defect 1

Condition: ☐ Sound ☐ Cracked ☐ Root Intrusion ☒ **Loose Brick** ☒ **Deteriorated**

chimney loose bricks,deteriorated, frame adj

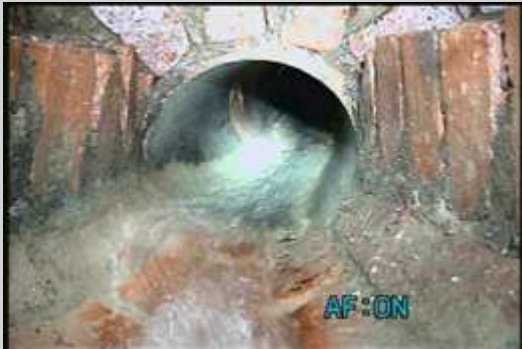
12 O'Clock Outflow

8 in. Circular Gravity Sewer
Pipe Out @ 12 O'Clock

Pipe Material: **Clay** ☐ Pipe Lined

Invert Depth: 11.10 (ft.) Flow Characteristics: **Fast**

Deposits: ☒ None ☐ Mud ☐ Sludge ☐ Debris ☐ Grease

Infiltration: **None** Pipe Seal Cond: **Unknown**

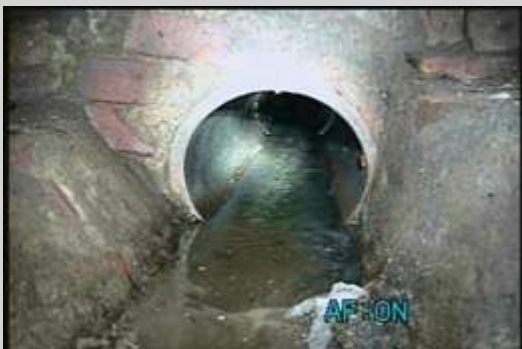
4 O'Clock Inflow

8 in. Circular Gravity Sewer
Pipe In @ 4 O'Clock

Pipe Material: **Clay** ☐ Pipe Lined

Invert Depth: 10.40 (ft.) Flow Characteristics: **Fast**

Deposits: ☒ None ☐ Mud ☐ Sludge ☐ Debris ☐ Grease

Infiltration: **None** Pipe Seal Cond: **Unknown**

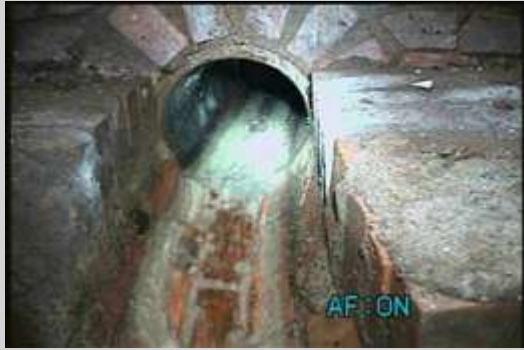
6 O'Clock Inflow

8 in. Circular Gravity Sewer

Pipe In @ 6 O'Clock

Pipe Material: **Clay** ☐ Pipe Lined

Invert Depth: **10.20** (ft.) Flow Characteristics: **Fast**

Deposits: ☒ None ☐ Mud ☐ Sludge ☐ Debris ☐ Grease

Infiltration: **None** Pipe Seal Cond: **Unknown**

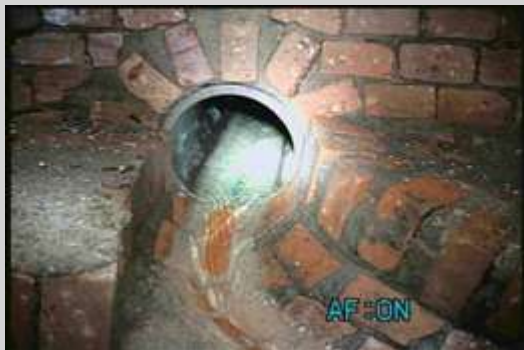
9 O'Clock Inflow

8 in. Circular Gravity Sewer

Pipe In @ 9 O'Clock

Pipe Material: **Clay** ☐ Pipe Lined

Invert Depth: **10.30** (ft.) Flow Characteristics: **Fast**

Deposits: ☒ None ☐ Mud ☐ Sludge ☐ Debris ☐ Grease

Infiltration: **None** Pipe Seal Cond: **Unknown**
